MSC APOLLO 13 INVESTIGATION TEAM

SPACECRAFT INCIDENT INVESTIGATION

VOLUME I ANOMALY INVESTIGATION

JUNE 1970

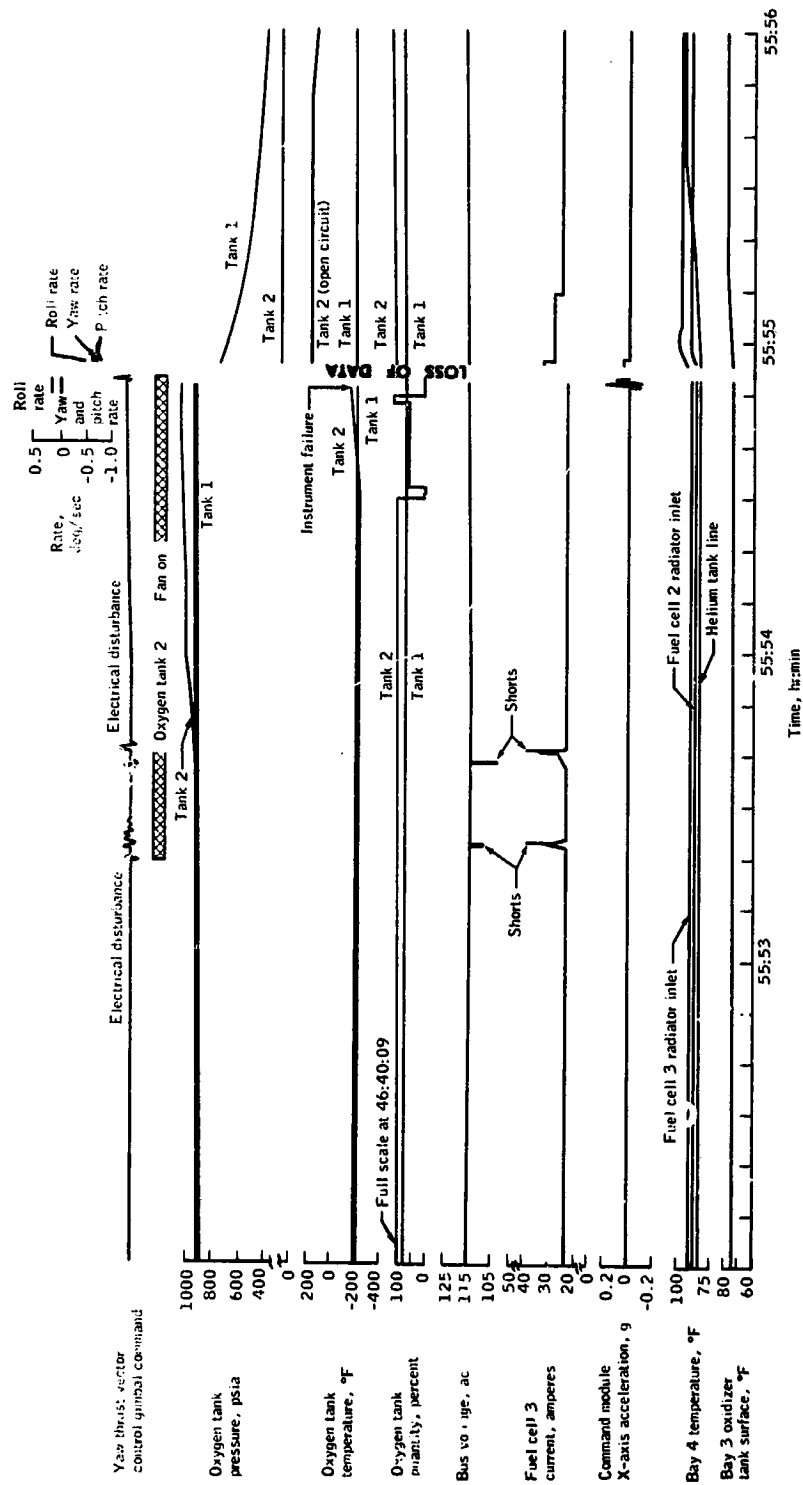
Figure 3-1.- Significant event timeline.

At 55:53:20, the electrical fan circuits for cryogenic oxygen tank 2 were energized. Approximately 2 seconds later, a momentary short was indicated in the current from fuel cell 3. Within several seconds, two other momentary shorted conditions occurred.

The temperature in the tank rose rapidly during the final 25 seconds of the pressure rise, then the measurement failed. The quantity gage, which had previously failed, corrected itself and then failed again.

The command module accelerometers responded to a vibration disturbance about 420 milliseconds after the last pressure reading and to an impulse about 340 milliseconds later. Approximately 40 milliseconds later, all data from the spacecraft were lost for about 1.8 seconds. Following recovery of the data, the spacecraft had experienced a translation change of 0.4 ft/sec primarily in a plane normal to the cryogenic oxygen tank bay. Cryogenic oxygen tank 2 pressure read zero. The cryogenic oxygen tank 1 pressure was decaying rapidly, and its heaters were on. A main bus B undervoltage alarm and a computer restart were present. Several structural temperatures in bays 3 and 4 were reading up to 8° F higher than before the data loss.

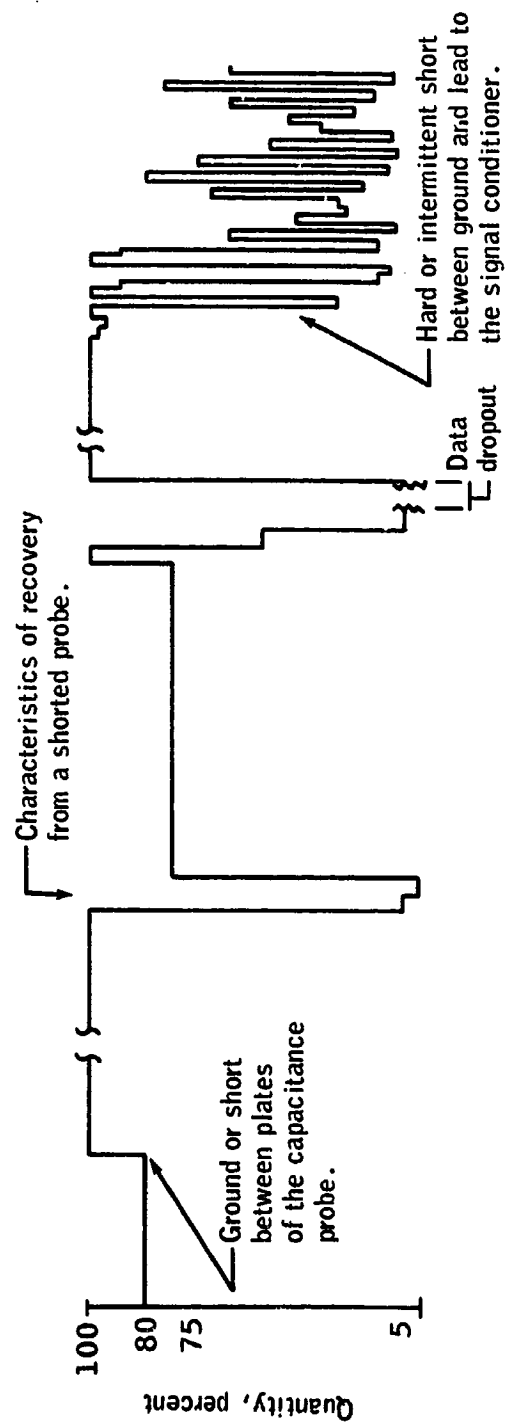
Figure 4-2.- Correlation of cryogenic oxygen tank 2 quantity flight data with measurement failure modes.

The first anomalous inflight condition associated with the cryogenic oxygen tank 2 occurred at 46:40:06 when the ac-powered destratification fans in both cryogenic oxygen tanks were turned on. Within about 3 seconds after fan activation, the quantity measurement for cryogenic oxygen tank 2 abruptly indicated full-scale high. This system indicates density of the cryogenic oxygen by measuring its dielectric constant, which is a function of density. This instrument is a capacitor which consists of two concentric aluminum tubes inside the tank (fig. 4-1).

Tests have shown that an open-circuit in the leads to the capacitor assembly or a short across the capacitor or its leads will drive the output to full scale. If this short-circuit is removed, the output signal drops abruptly from full scale to zero, and then in about a second, it settles out to the proper reading, as noted in the data of figure 4-2. This agrees with the flight data from the quantity probe. Tests also show that if the inner tube is shorted to ground, the output may oscillate in a random manner. Such an oscillation was noted several minutes after data recovery following the incident. It should be noted that with a short-circuit in the quantity gaging system inside the tank, the maximum current that could be drawn is 15 milliamperes.

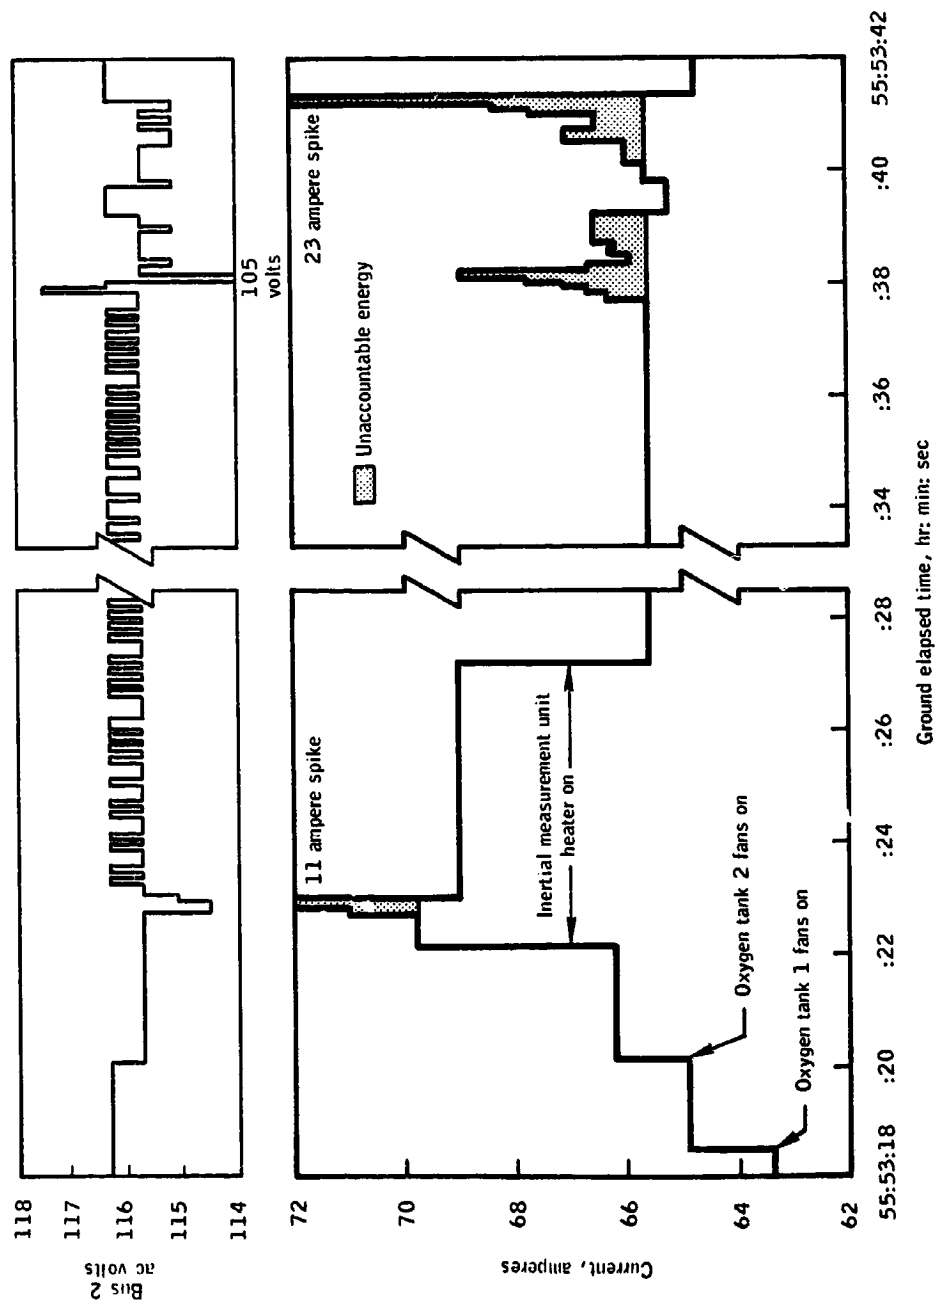
Figure 4-5.- Spacecraft current and ac voltage during period of interest.

The first indication of a short on ac bus 2 appeared about 2-1/2 seconds after activation of the cryogenic oxygen tank 2 fans. The ac bus 2 voltage dropped 1.2 volts, the fuel cell 3 current increased 11 amperes (fig. 4-5), and the stabilization and control system gimbal command data experienced a transient. Subsequent to the short, the spacecraft current data show a decrease of 0.8 ampere from the level just prior to the short. Also, the ac bus 2 voltage started to toggle-up 0.6 volt, or one data bit (fig. 4-5). These data indicate that a load was removed from ac bus 2 and that it was approximately one-half the load normally applied when the cryogenic oxygen tank 2 fans were turned on. This indicates that a short in one of the two fan motor circuits in cryogenic oxygen tank 2 caused its fuses to blow.

Approximately 200 milliseconds later, the ac bus 2 voltage momentarily decreased 11 volts (fig. 4-5), and the total spacecraft current increased 3.5 amperes, indicating an increased load. After the momentary decrease, the ac bus 2 voltage reading was 0.6 volt less than the previous indication. This could be an indication that a single phase short on phase B or C was removed by blowing a fuse.

About 20 seconds after the first short, the third ac bus 2 short occurred. Fuel cell 3 current increased 23 amperes, and the stabilization and control system data again indicated a transient (fig. 3-1). Subsequently, the total spacecraft current level decreased to the same level as it was prior to turning on the cryogenic oxygen tank 2 fans. This indicates that power to the remaining cryogenic oxygen tank 2 fan was removed by blowing its fuses due to this short. Also, the ac bus 2 voltage increased to the same level as that prior to turning the tank 2 fans on (fig. 4-5).

The electrical energy that could not be accounted for by normal spacecraft loads (fig. 4-5) is attributed to the shorts. Calculations were made of the maximum energy levels that could have been transmitted through the circuit during these shorted conditions and that would still meet the constraints imposed by the flight data resolution and sampling times, inverter performance, fuse clearing time, and dc and ac bus voltage sensor performance. Inverter performance and fuse clearing time tests were performed to provide data for the energy calculations. The energy calculations are summarized in table 4-I.

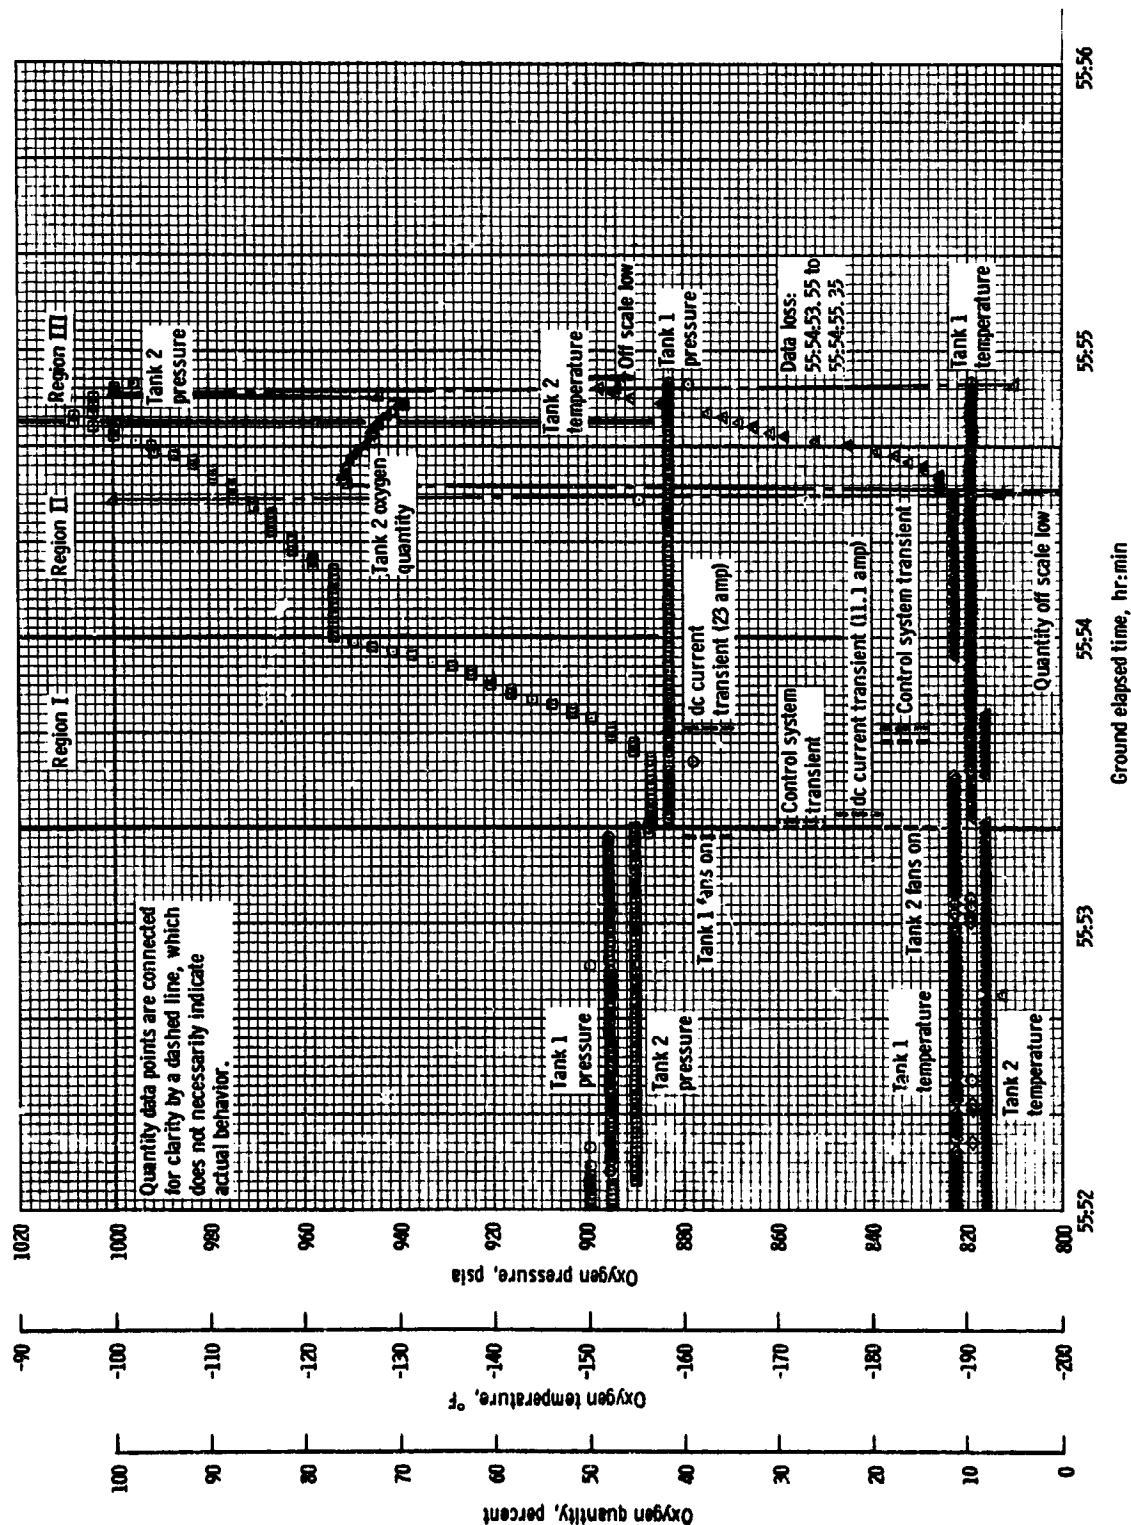
Figure 4-10. - Pressures, temperatures, and quantities during period of interest.

While the pressure was rising sharply in cryogenic oxygen tank 2, changes occurred in the temperature indication (fig. 4-10). The temperature data are obtained from a sensor located on the quantity probe assembly (fig. 4-8) within the tank. The temperature increased about 2° F during the first pressure rise (region I). A temperature increase of this magnitude is in accord with that expected due to the pressure rise alone.

The significant aspect of the temperature data is the rapid rise rate commencing approximately 24 seconds prior to loss of data (fig. 4-10). Several analyses were performed to interpret the data. The results indicated that a temperature range of 600° to 2900° F could produce the observed response. This wide temperature span is a result of the geometric configurations which are possible. The significant results from these analyses confirmed that the combustion source was near the sensor during the period of rapid temperature rise. Just prior to the loss of data, the temperature dropped to zero, indicating an open circuit failure in the measurement circuit.

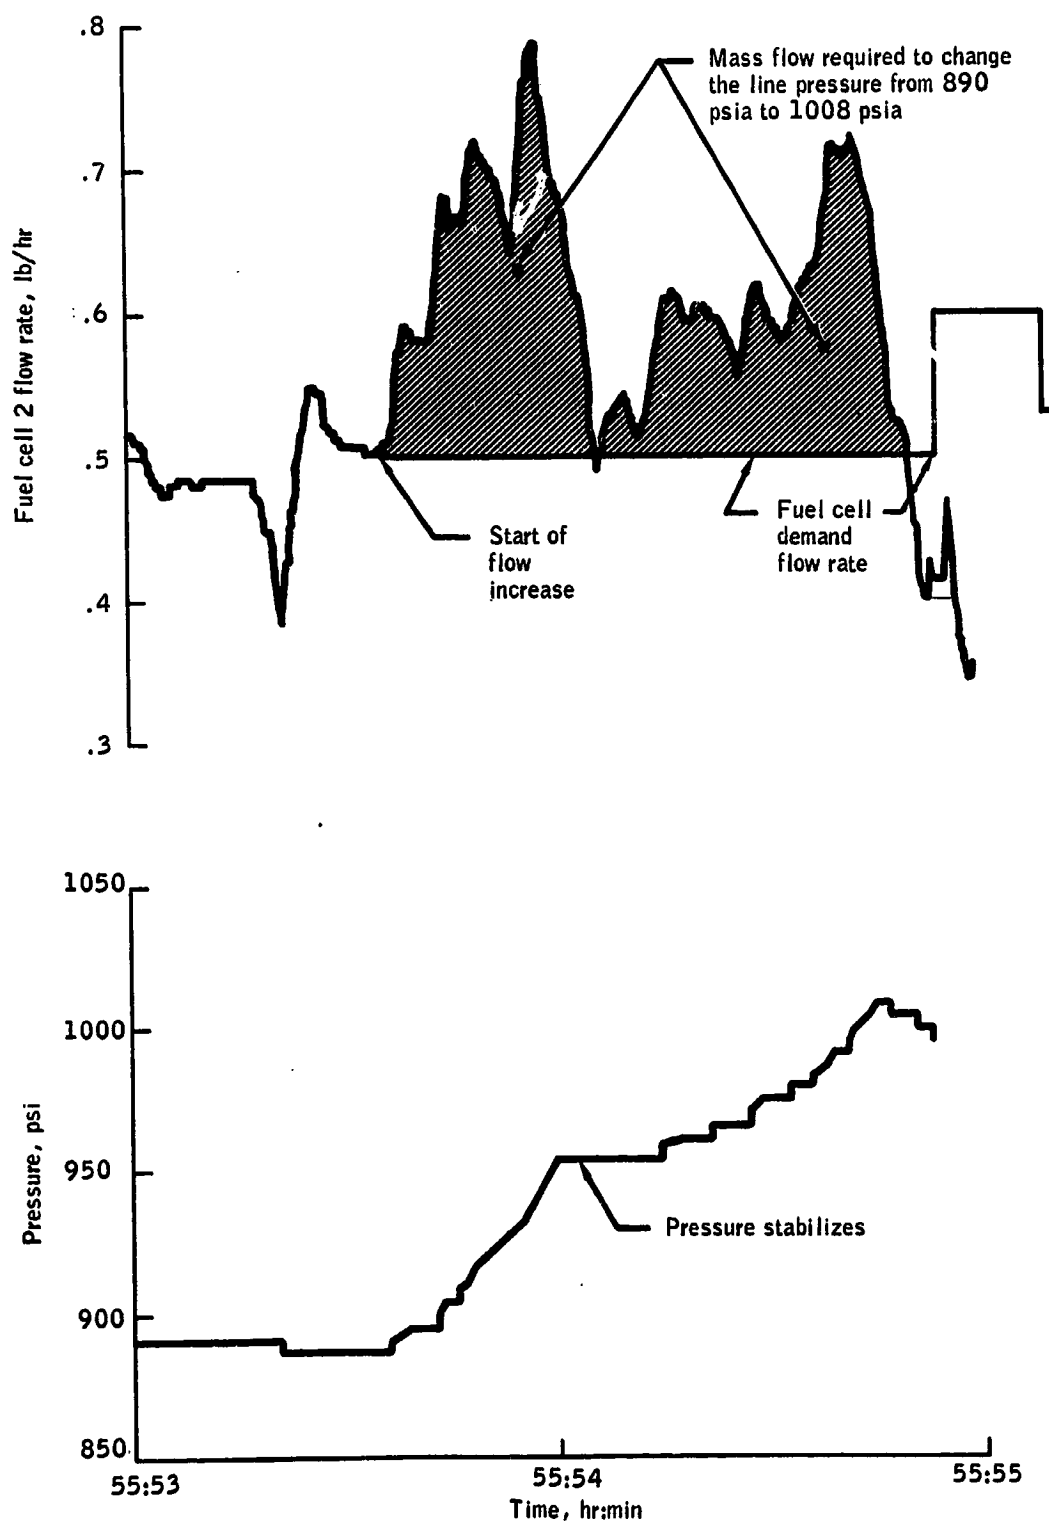
Figure 4-11.- Effect of oxygen pressure on fuel cell flow rates.

Another validation of the pressure transducer under dynamic pressure conditions consisted of integrating the flow rate change to the fuel cell (fig. 4-11). This calculation substantiated the tank pressure peak as about 1008 psia. Throughout the mission, both tank pressures were reading as expected, further substantiating their validity.

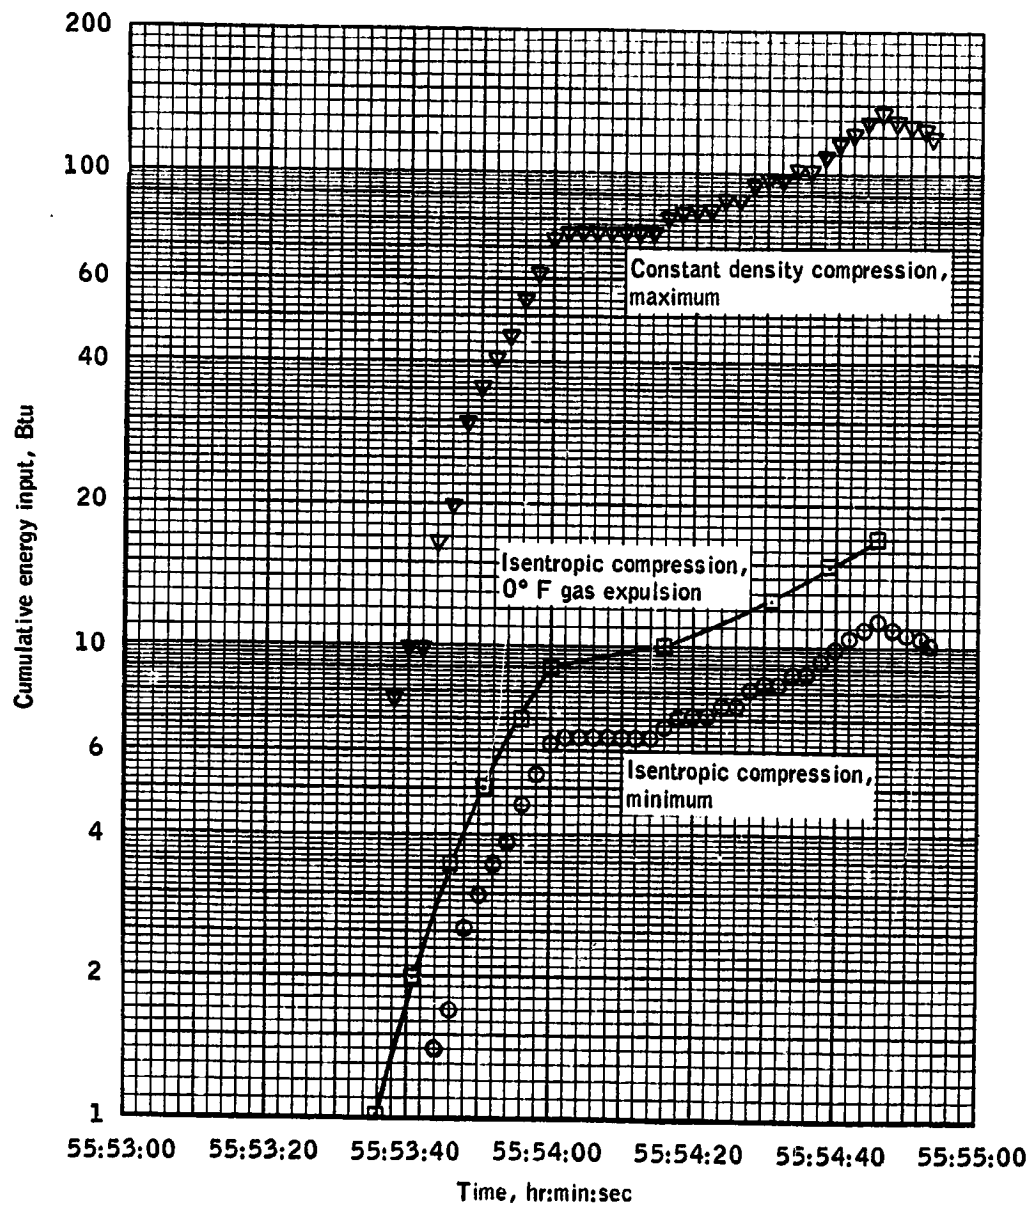
Figure 4-12.- Oxygen tank 2 energy addition.

The maximum energy input to satisfy the observed pressure rise is a constant density heating process. This condition is shown by the upper curve of figure 4-12. A second process, which establishes the minimum energy input, is an isentropic compression of the fluid. This compression is represented by all the energy input being confined to a small bubble, which has no mass. The resulting thermodynamic state is one of higher pressure in the tank. The result of this process is depicted by the lower curve of figure 4-12.

In actuality, the energy input into the tank lies somewhere between the maximum and minimum energy input curves shown in the figure. The process is modeled by a hot oxygen bubble of constant uniform temperature, growing at a rate sufficient to isentropically compress the surrounding cryogenic oxygen. This formulation accounts for mass transfer both to the hot mass (to increase the volume) and from the hot mass (tank outflow). This mass transfer requires a larger energy input to sustain the pressure rise. The center curve of figure 4-12 shows a comparison of this model with the maximum and minimum energy models. The results (fig. 4-13) are dependent upon the temperature of the hot mass. Note that while the energy input increases by approximately 300 percent, the hot mass volume changes only 10 percent. Therefore the energy source is confined to a small region within the tank, and is essentially independent of the temperature of the burning material.

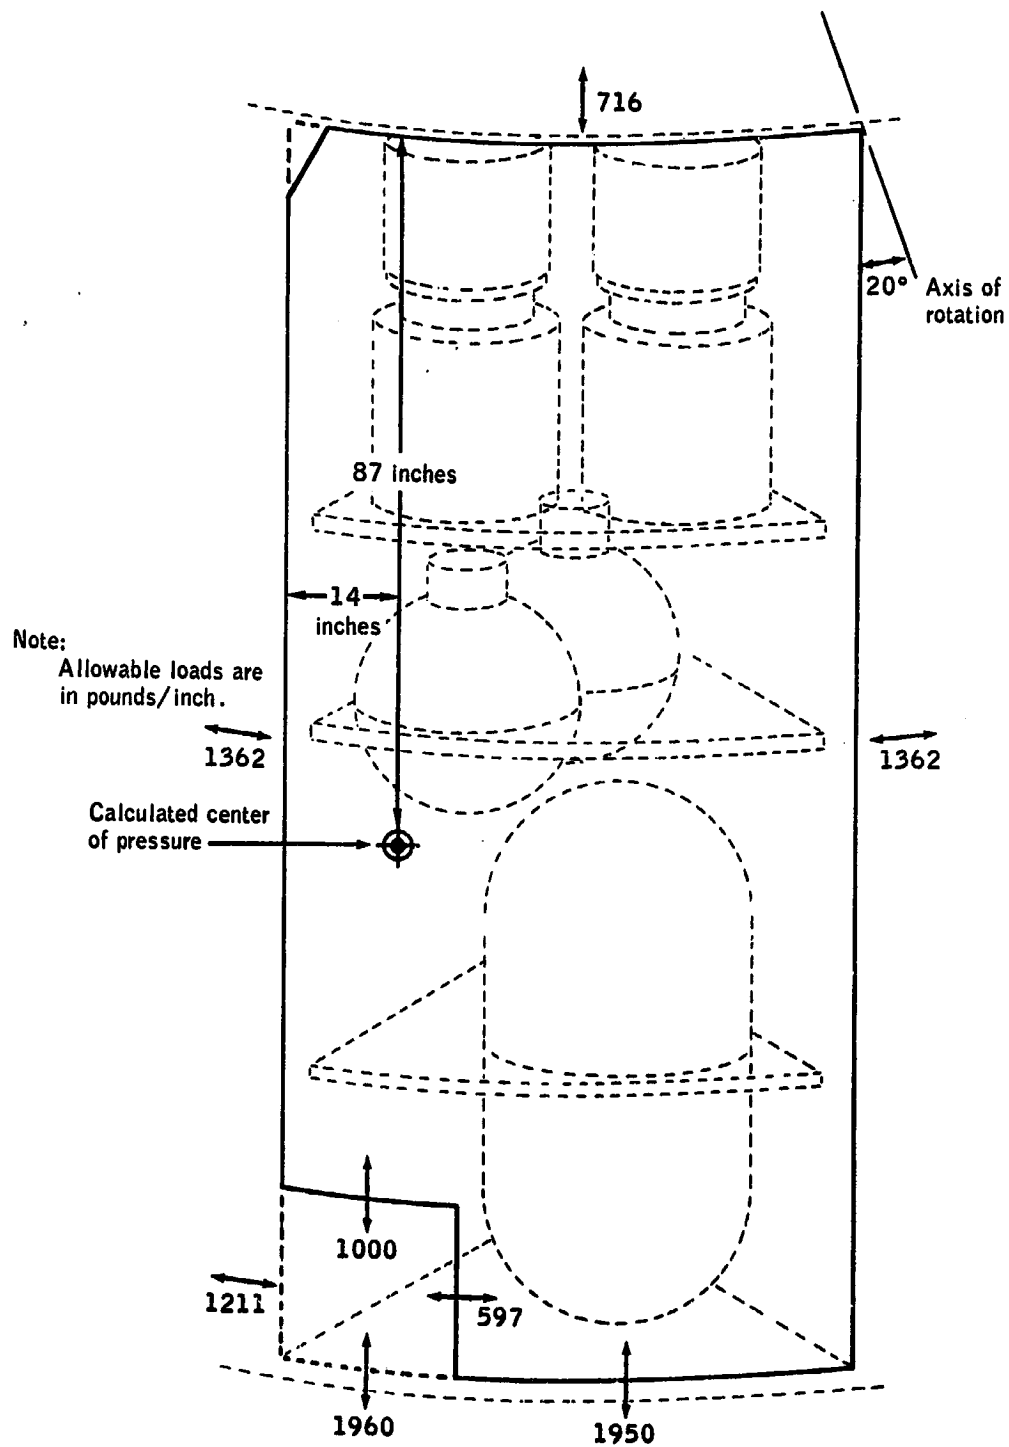
Figure 4-23.- Joint design allowables and axis of rotation.

Because of the evidence which suggested primarily membrane behavior, simplified representations of the structure were used to investigate its behavior. Structural analyses were performed for numerous pressure distribution as well as for temperature gradients for both hot and cold inner facesheets. The results show that the peak pressure must exceed 20 psi and that temperature gradients of interest result in small edge loads. The static allowables for failure with a failure mode of shear tearout are shown in figure 4-23.

c. The foregoing analysis is consistent with the available strength (fig. 4-23). The axis of rotation required to satisfy the kinematics of panel separation, the available strength, and the photographic evidence support the origin of failure on the left side of the panel as viewed from the exterior. The response of the Y and Z axes accelerometers noted at 55:54:53.531 is consistent with a minus Y and minus Z force applied over 15 to 20 milliseconds. Analysis of the vehicle dynamics indicates a 900 to 1500 lb-sec impulse was experienced by the spacecraft. Such an impulse would require an initial total force greater than 60 000 pounds. The variation in strength with a failure mode of shear tearout in the panel is shown for loads applied perpendicular to the boundary. The allowable load applied parallel to the boundary is bounded by shear of the fastener at approximately 2200 lb/in.

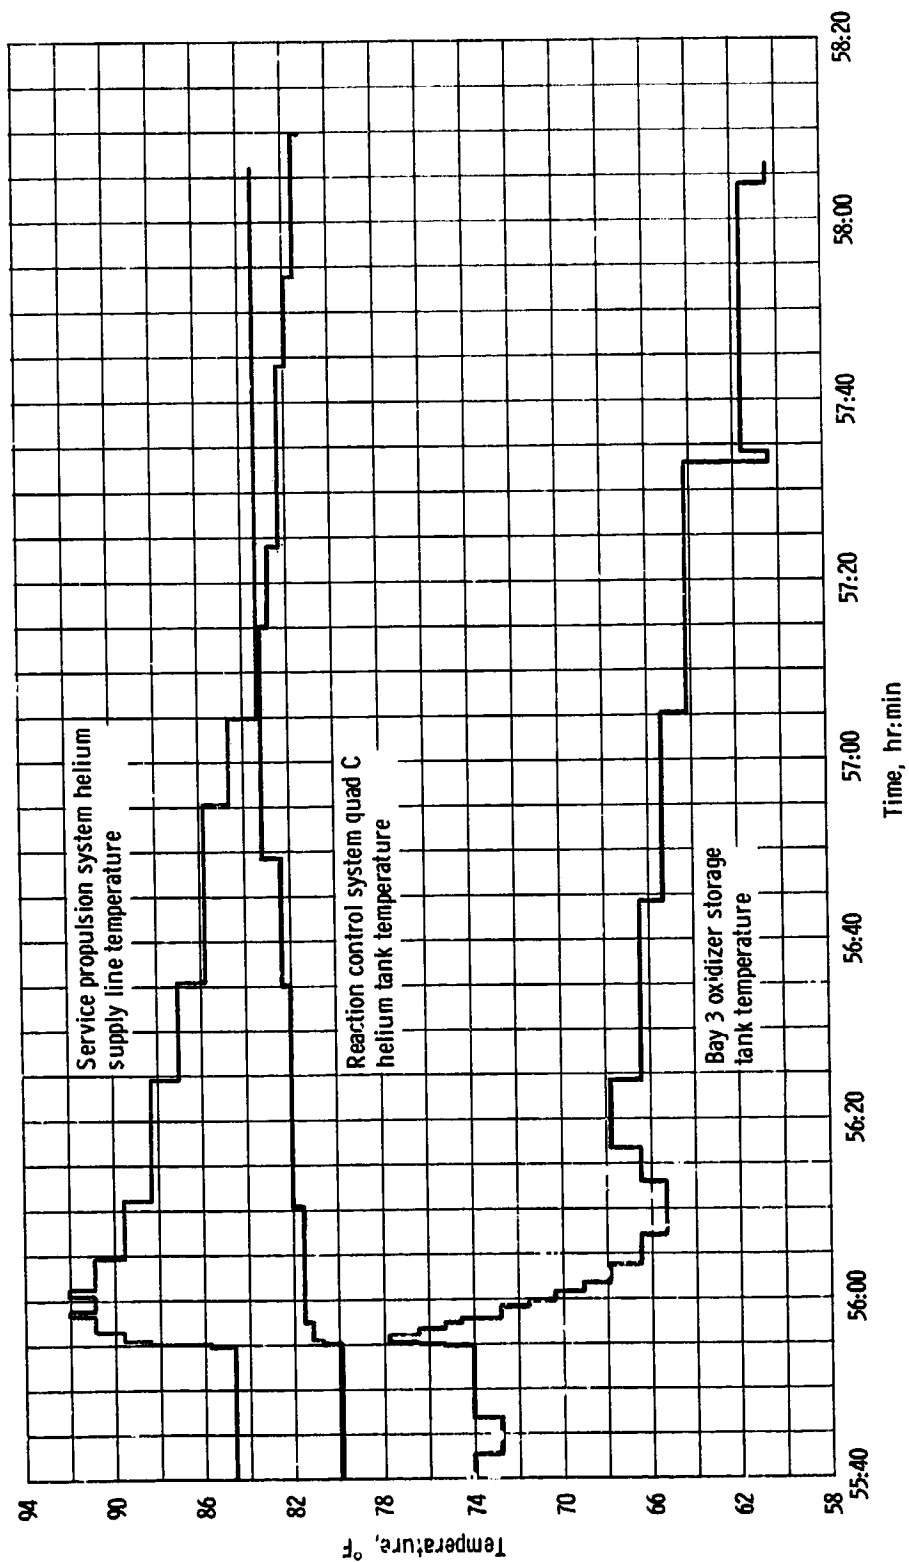
Figure 4-32. - Bay 3 and 4 structural temperatures.

The bay 3 oxidizer tank surface temperature increased from 73.4° to 77.7° F in about 20 seconds (fig. 4-32). The temperature then decreased to 60° F about 2-1/4 hours later. Data received during the two command and service module power-up cycles at 101:55.54 and 123:05:25 showed 60° and 65.3° F, respectively. The rise rate of bay 3 service propulsion system oxidizer surface temperature is indicative of direct heating in the vicinity of the transducer, which is attached to the tank skin and covered with 30 layers of insulation.

Heat inputs to the bay 3 service propulsion tank surface transducer depend on the thermal integrity of the multilayer insulation blanket covering the transducer. To obtain the noted response requires severely degraded insulation, probably because of burning of the insulation or pressurization of the bay with hot gas.

The service propulsion helium line temperature (fig. 4-32) increased from 84.6° to 89° F in about 37 seconds. In 2 more minutes, the temperature had increased to 92.2° F. A gradual cooling trend followed, and 10 minutes later, the temperature had decreased to 83.4° F. During the two command and service module power-up cycles at 101:55:54 and 123:05:19, the helium line temperatures were 72.1° and 65.9° F, respectively. The initial rise rate is again indicative of direct heating in the vicinity of the transducer. However, unlike the oxidizer tank surface temperature, the gradual decrease in helium line temperature, after the initial rise, is indicative of a cool-down response to radiant heat loss. The helium line cooled gradually because of the lower temperature levels with the fuel cells shut down and the bay 4 panel missing.

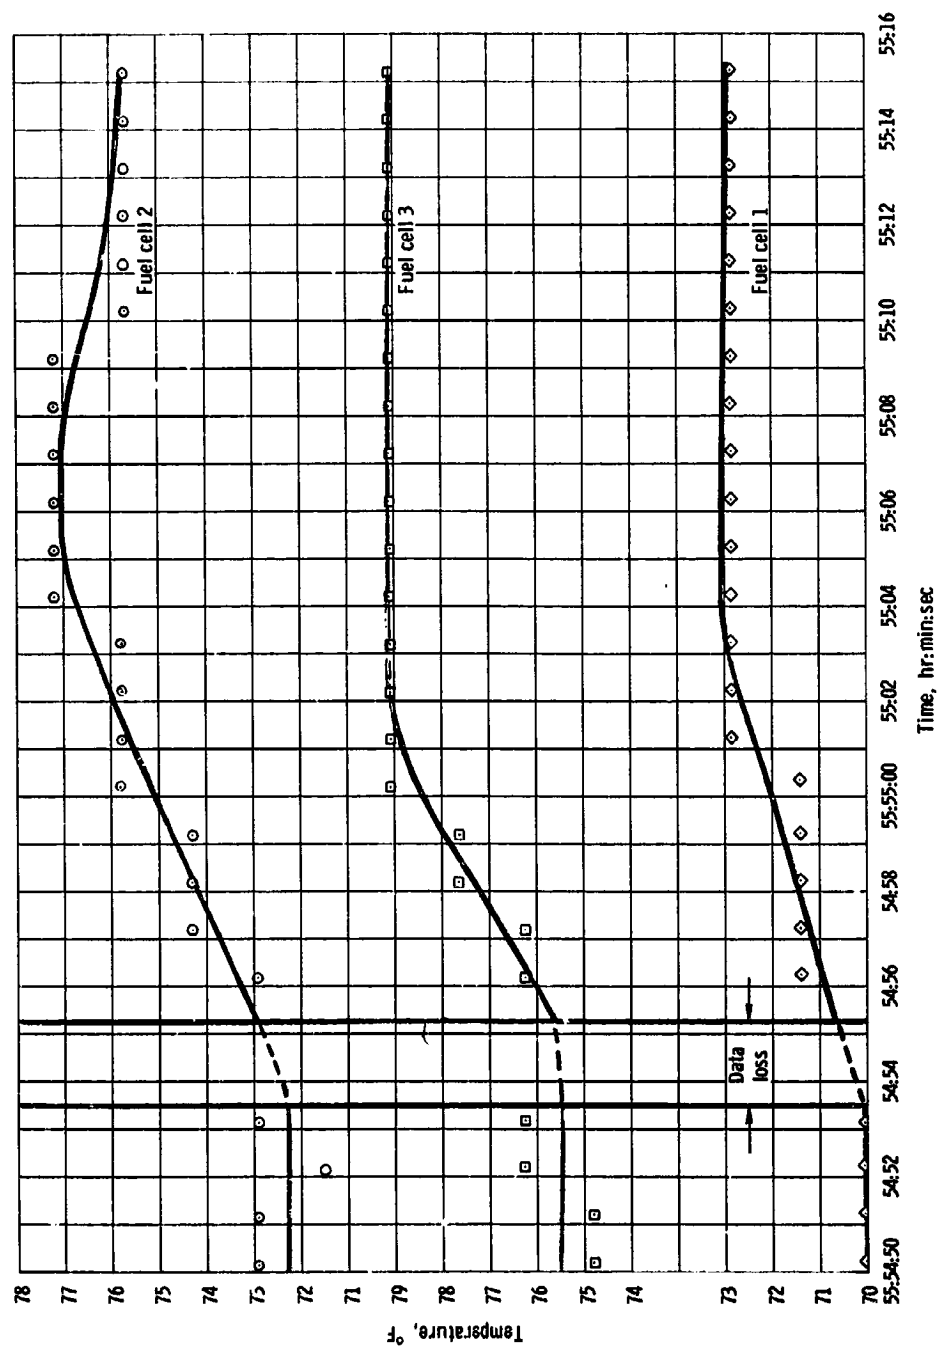
Figure 4-33. - Concluded.

Although all fuel cell radiator glycol inlet and outlet temperatures showed perturbations, the fuel cell 3 radiator inlet temperatures exhibited the largest response. The temperature increased from 93.1° to 97.4° F in 3 seconds or less. This represents the highest response rate noted from any of the transducers at the time of the incident. The data for fuel cell 3 radiator inlet temperature, and for other transducers, are shown in figure 4-33. A correlation of these data has been performed and it is concluded that these transducers could have been exposed to a sudden change in temperature environment prior to the data loss. An extrapolation can be made which would support the response noted at the time of the heat pulse (fig. 4-33), but it would depend on the heat input function. Tests performed with the temperature sensor installed on the glycol line and with glycol flowing indicate that the heat pulse would lead the rise point by about 0.25 second. The rise point can reasonably be extended to any time during the data loss. Assuming the rise point started at the time of the data loss, then the heat pulse would have started at approximately the same time as the accelerometer disturbances, indicating that the high heating rate started before the bay 4 panel separated. The data indicate that the high-heating environment extended throughout bays 3 and 4.

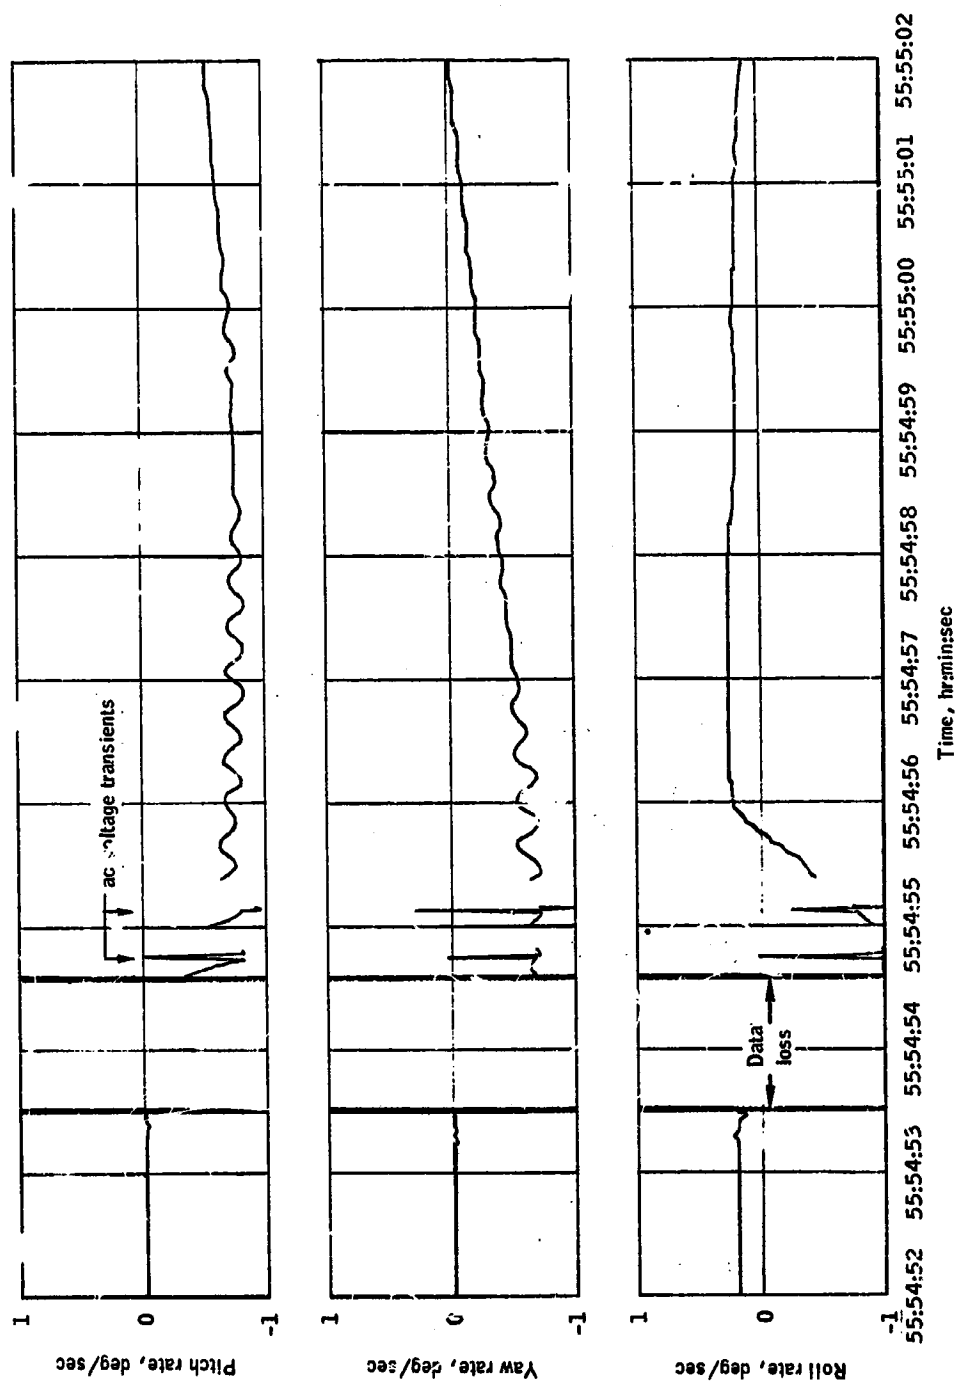
Figure 4-34. - Spacecraft dynamics during cryogenic oxygen tank 2 anomaly.

The stabilization and control system recorded the small body rate oscillations described in section 4.6, at 0.28 second before the loss of data. When data were regained, negative rates were present in all three axes (fig. 4-34). The oscillations shown in the pitch and yaw axes on the figure are predominantly due to excitation of the first bending mode (2.7 hertz). The reaction control engine firings which occurred following resumption of data were proper for the conditions that existed. The resulting angular accelerations in pitch and roll, however, indicate that only one thruster was acting in each axis and that quad C was inoperative. The total attitude change was small (fig. 4-35).

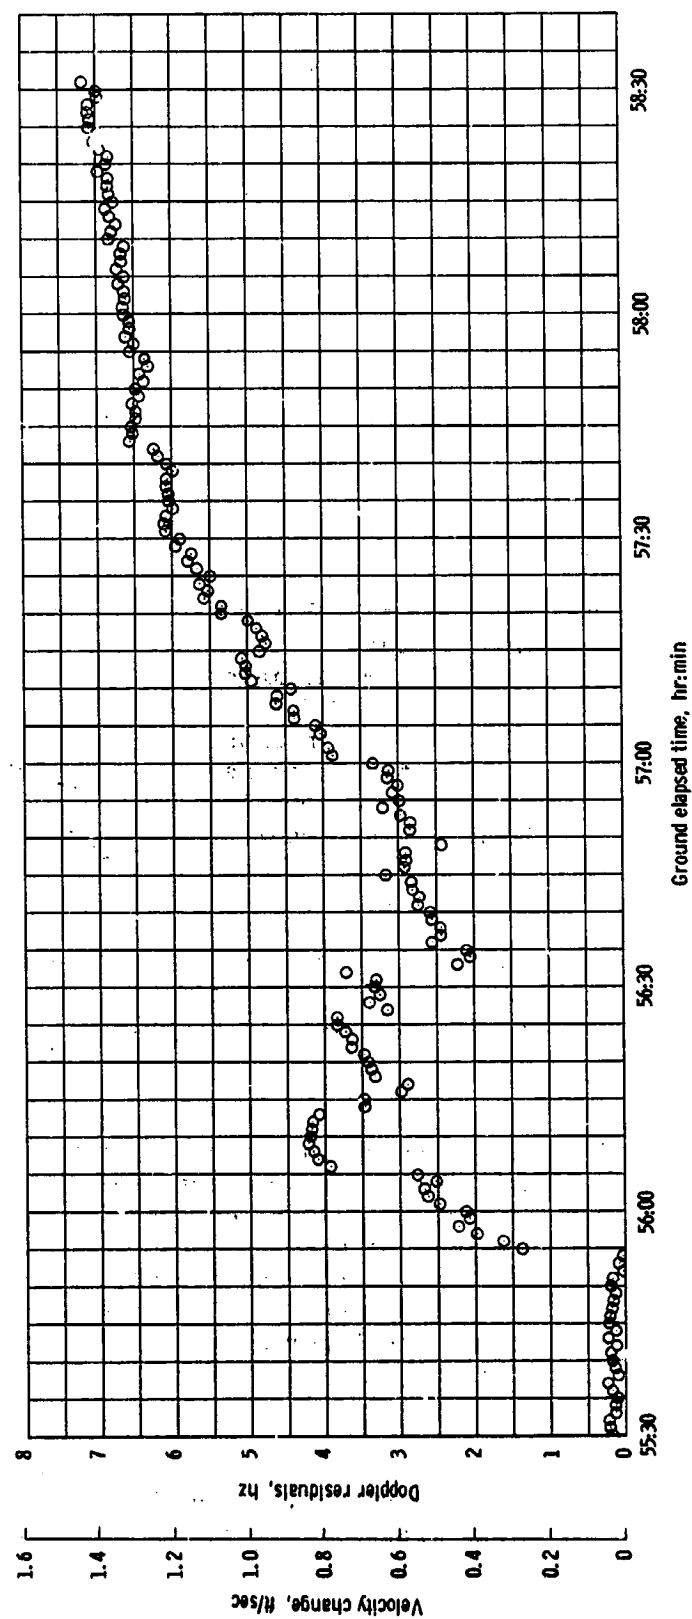
Figure 4-37. - Network doppler data during period of interest.

Venting followed the incident and attitude control was maintained automatically by the digital autopilot until the loss of main bus B when the last minus pitch thruster was disabled. Periodic attempts were made to reestablish attitude control manually using the thruster emergency coils until the thrusters were reconfigured to main A. The venting disturbance torque is shown in figure 4-36. Figure 4-37 contains a time history of network doppler data and shows the effect of venting as well as uncoupled thruster firings.

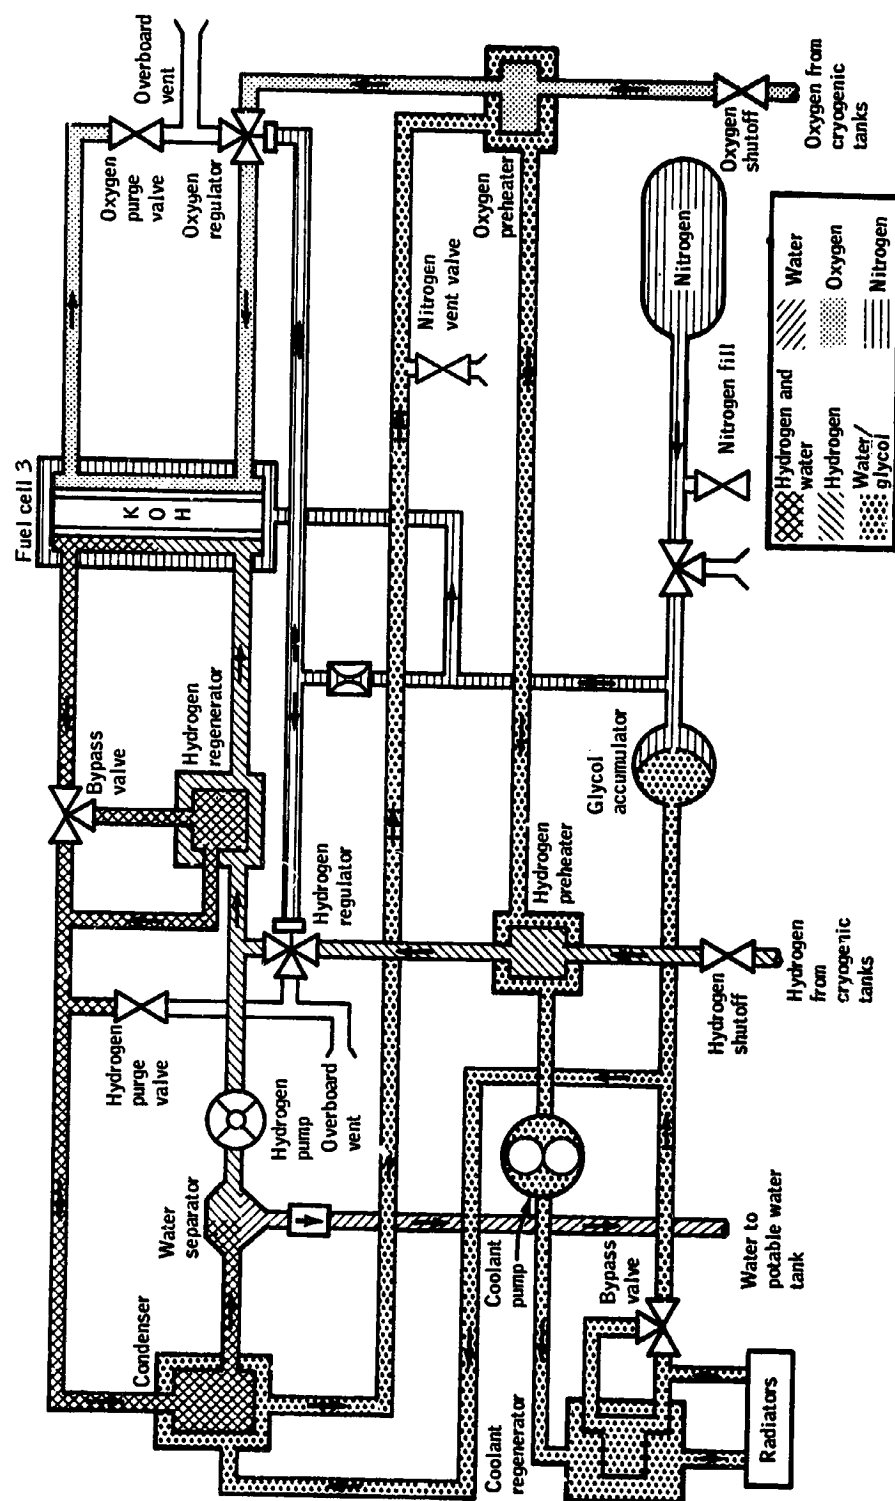
Figure 4-38.- Typical fuel cell schematic.

Three fuel cells are located in bay 4 of the service module (fig. 3-2). Each fuel cell consists of a cell stack, hydrogen and oxygen control systems, a water removal system, and a thermal control and heat rejection system (fig. 4-38).

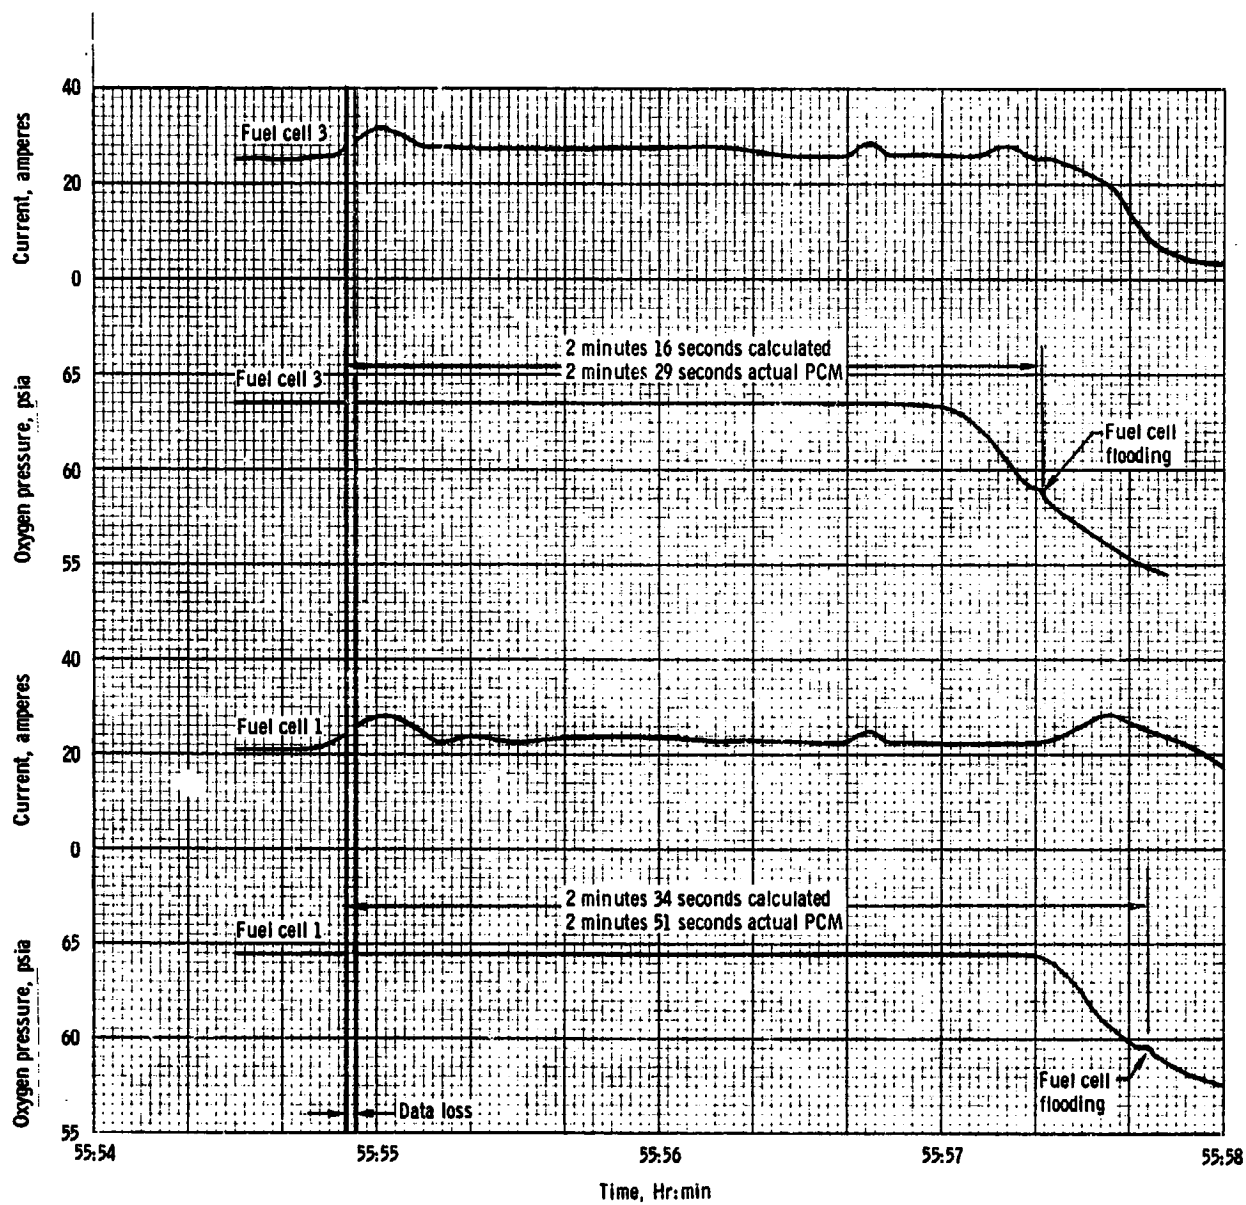
Figure 4-40. - Fuel cells 1 and 3 performance loss.

The pressure decays on fuel cells 1 and 3 were caused by closure of the fuel cell oxygen reactant shutoff valves. When the valves closed, a volume of high pressure oxygen was trapped between the reactant valves

and the fuel cell oxygen regulators. This oxygen was sufficient for fuel cell operation for about 2.5 minutes, the time required to deplete the trapped supply. The agreement between the calculated and actual operating time after valve closure (fig. 4-40) verifies that fuel cells 1 and 3 were starved of oxygen and eventually could not support an electrical load.

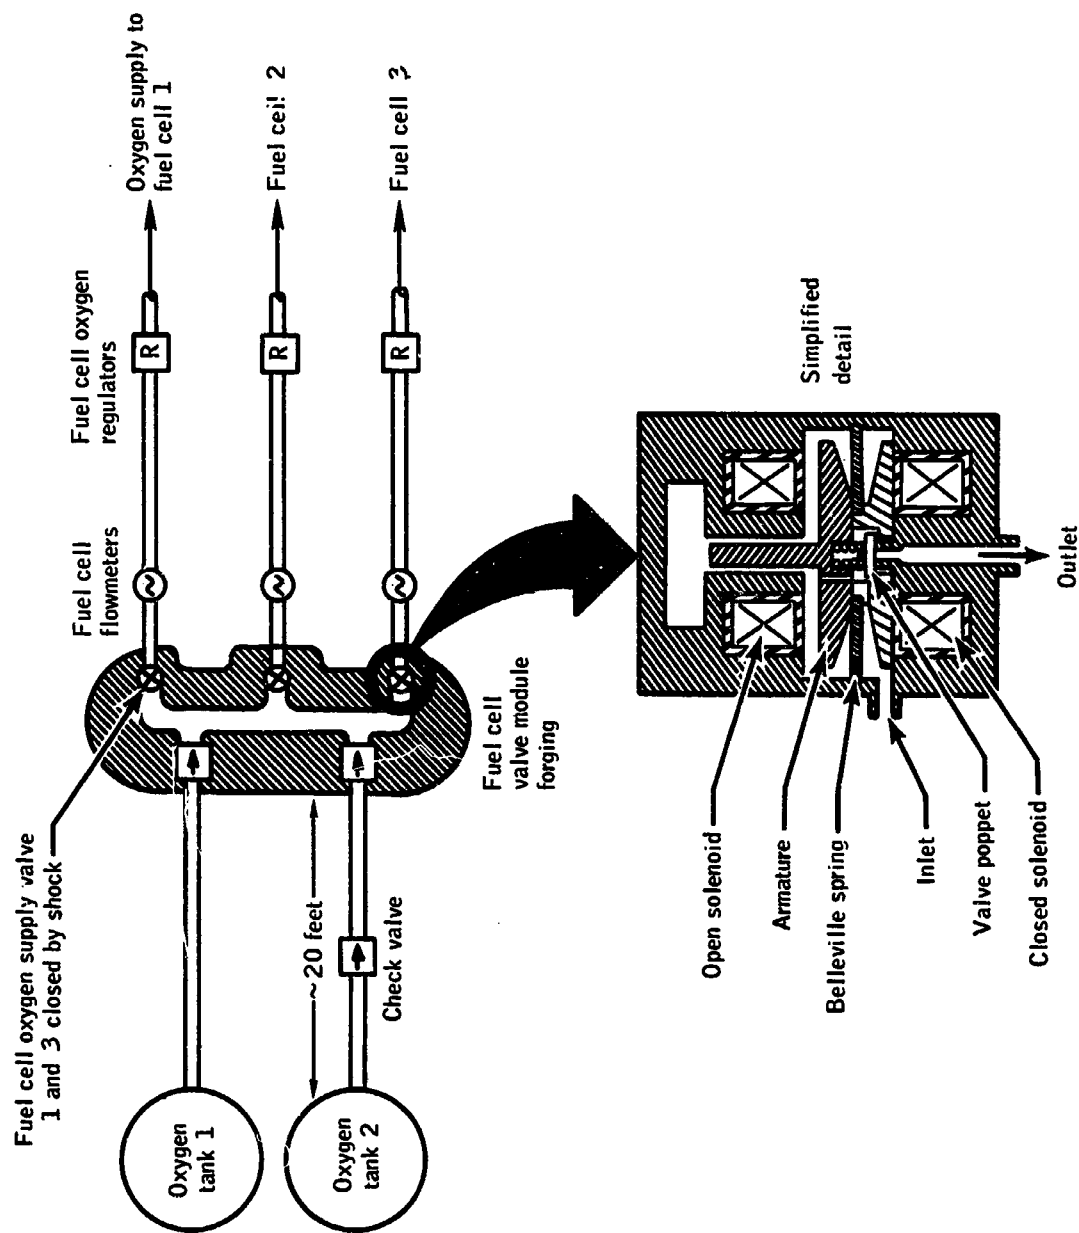
Figure 4-41.- Solenoid valves for oxygen supply.

Impact tests on the oxygen solenoid valves (fig. 4-41) show that a shock in excess of 86g for 11 milliseconds duration can be expected to cause valve closure under operating conditions.
